Manhole Inspection Summary

Manhole # S19MM_001MH

Location Address: **ON THE SIDE OF 2100 CLIFTON AVE** Cross Street: **PAYSON ST**

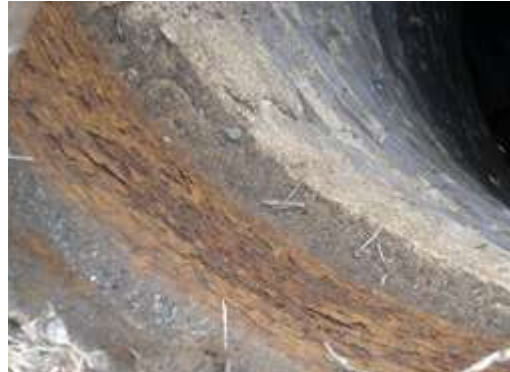
Defect 2

Frame Offset: **1** (in.) Condition: ☒ Sound ☐ Cracked ☐ Leaks

FRAME OFFSET

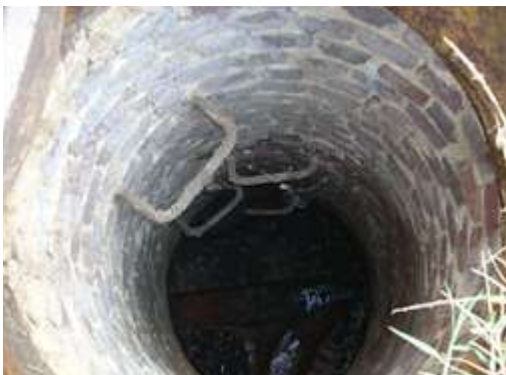
Defect 1

Steps Count: **4** Missing: **0** ☒ **Corroded**

CORRODED STEPS

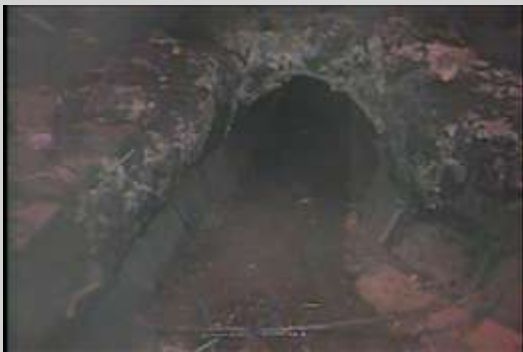
12 O'Clock Outflow

8 in. Circular Gravity Sewer
Pipe Out @ 12 O'Clock

Pipe Height: **9.6** (in.) Rod and Bar (Angled)
Pipe Material: **Clay** ☐ Pipe Lined
Invert Depth: **10.76** (ft.) Flow Characteristics: **Slow**
Deposits: ☒ None ☐ Mud ☐ Sludge ☐ **Debris** ☐ Grease
Silt Depth: (in.) Deposits Extent:
Infiltration: **None** Pipe Seal Cond: **Sound**

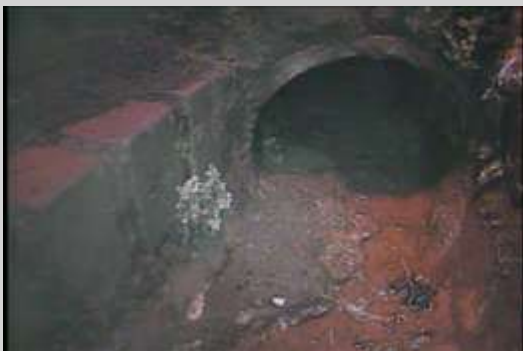
3 O'Clock Inflow

8 in. Circular Gravity Sewer
Pipe In @ 3 O'Clock

Pipe Height: **8.4** (in.) Rod and Bar (Angled)
Pipe Material: **Clay** ☐ Pipe Lined
Invert Depth: **10.72** (ft.) Flow Characteristics: **Slow**
Deposits: ☐ None ☐ Mud ☐ Sludge ☒ **Debris** ☐ Grease
Silt Depth: **2** (in.) Deposits Extent: **Light**
Infiltration: **None** Pipe Seal Cond: **Sound**
